NEVER RUST

STEM WALL REPAIR SYSTEM

Stem Wall Repair

By Bob Brown

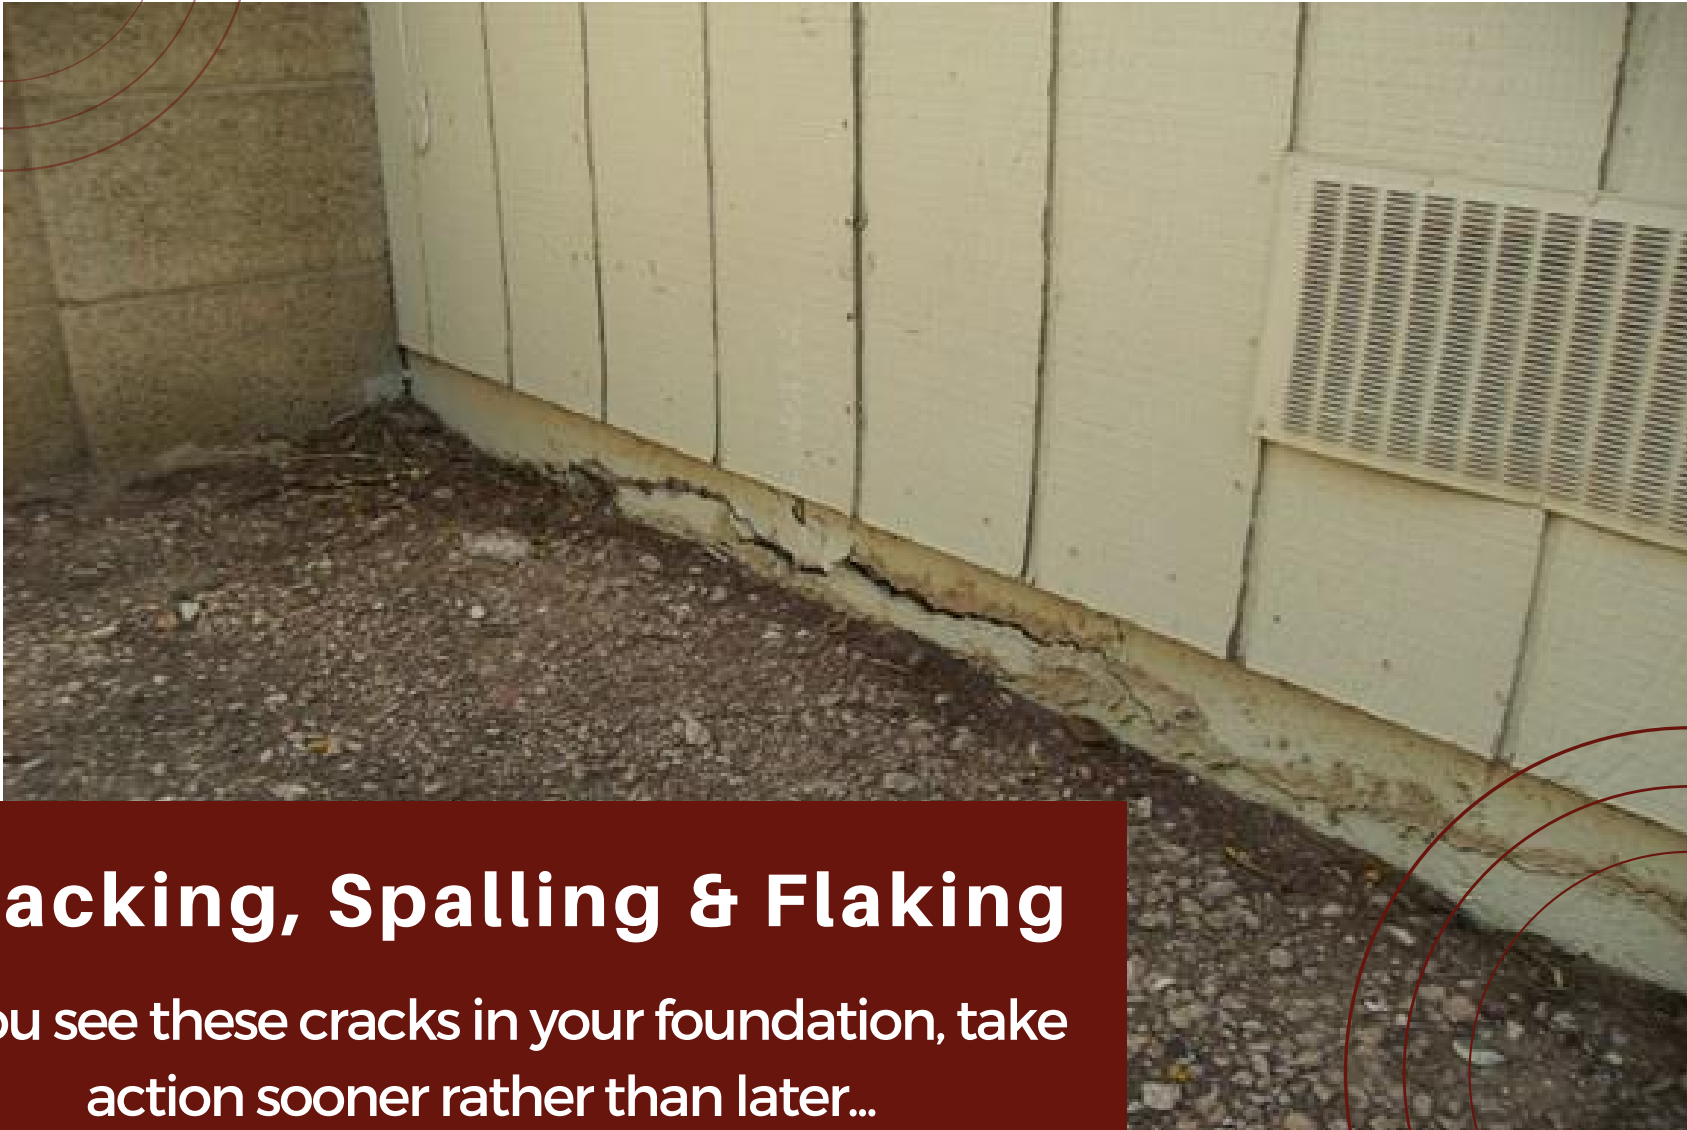
Cracking, Spalling & Flaking

If you see these cracks in your foundation, take action sooner rather than later...

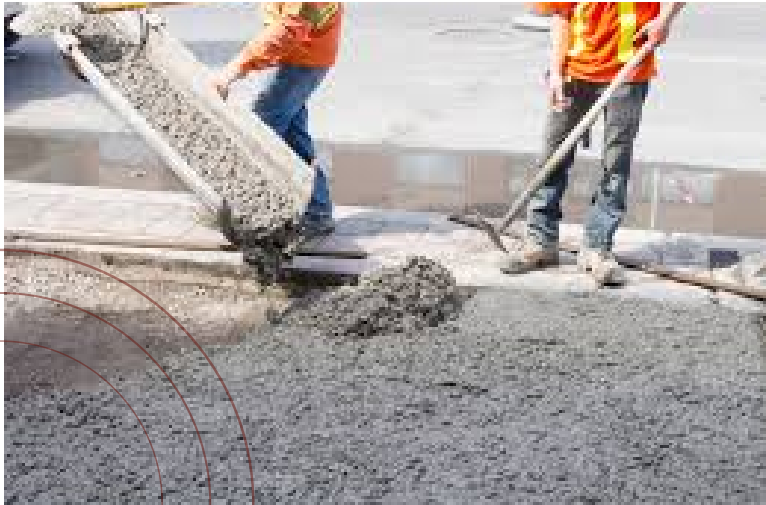
When it is initially placed, concrete has a high PH level around 12 or 13. This is a high alkaline environment and initially protects the rebar from rusting. Over time it drops to around 8 to 8.5 because of carbonization.

The process that geologists refer to as mass wasting. Rain with CO₂ in it (acid rain) slowly over time reacts with the cement in concrete lowering its PH level toward a more acid level.

Concrete has millions of microscopic pores that hold water. Water usually is in these pores, from initial placement or exposure to water over time. It has a natural humidity and affinity for water.

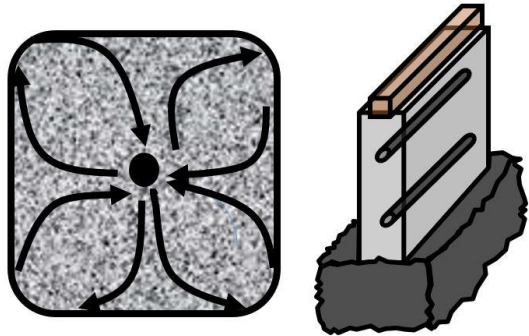
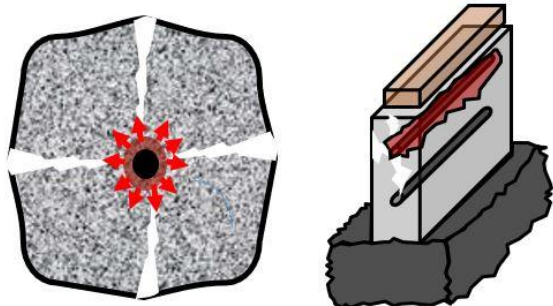
Circular micro electrochemical currents.

oxidization = rust.

As the concrete lowers from an alkaline PH level toward and acid one, tiny micro chemical electrical currents develop.

These tiny electrochemical currents deposit chloride ions on to the embedded rebar or any other iron products that help catalyze rapid oxidization of the iron...rusting.

As Iron rusts it loses strength and grows in volume. However as it is trapped and encased in concrete, when it grows, it puts pressure on the concrete, cracking it and continuing until the concrete is completely broken apart.

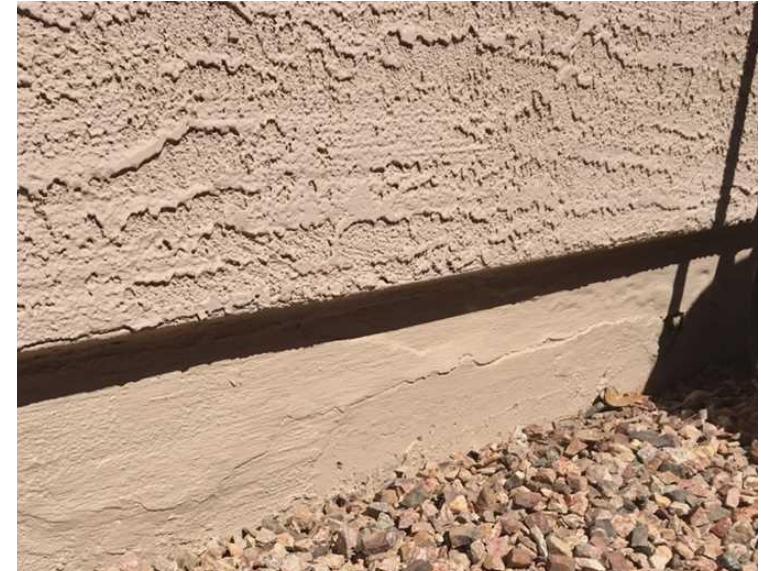
As the concrete deteriorates, it loses its ability to hold the walls above it and can shear off as shown to the left along the red dashed line.

Expanding rebar is the principle reason of concrete failure.

This may cause structural failure in short amount of time!

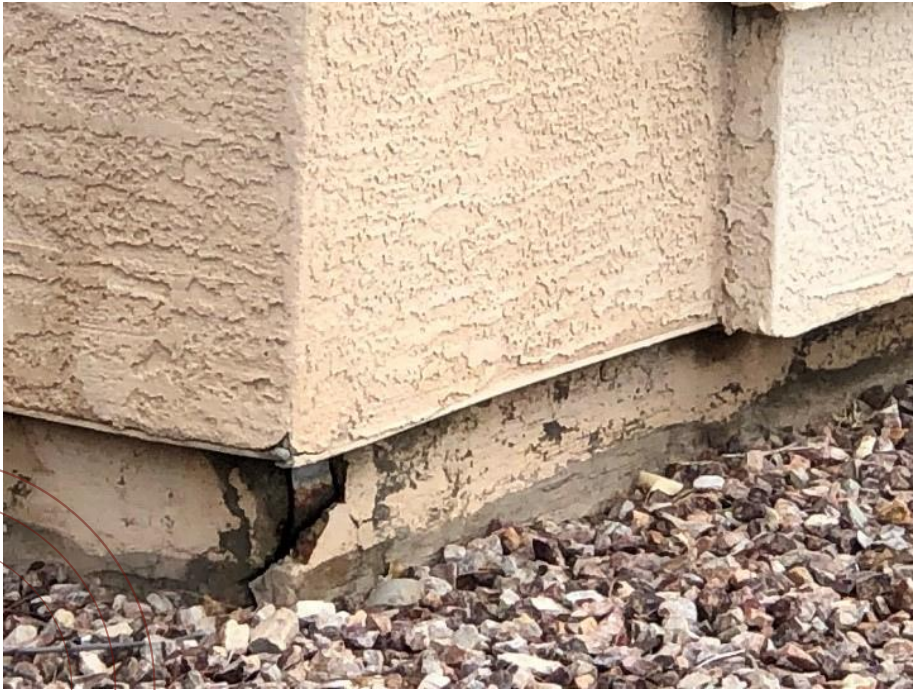
There are more problems with embedments than just rebar. Homes with frame construction (not masonry) have hold down straps. These are designed to make sure that the house stays secured to the foundation in high winds.

These straps attach to the framing stud with 24 screws along the outside of the wall (under the stucco) and continue down into the concrete stem wall. Since they are fastened to the outer edge of the stud, they enter the stem wall on the outer edge and then continue on an angle to the middle of the concrete

Code requires all embedments to be at least 1.5" from the edge. By definition then none of these straps meet code. They are constructed of thin 1/16" thick materials and are zinc coated. However the zinc coating only protects for a short time because it is so thin. A very short time. Once they are deteriorated there is no hold down connection from the house to the foundation. By the time rebar is cracking the concrete, the tie down straps have almost always lost their ability to do any good whatsoever.

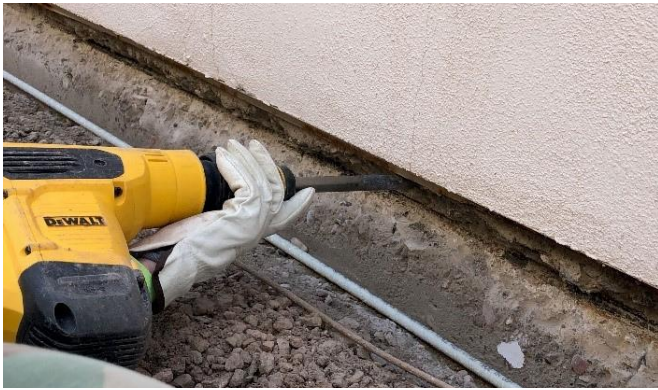
Step One

Chip away deteriorated concrete to fractured rock strata, removing all ferrous oxide.

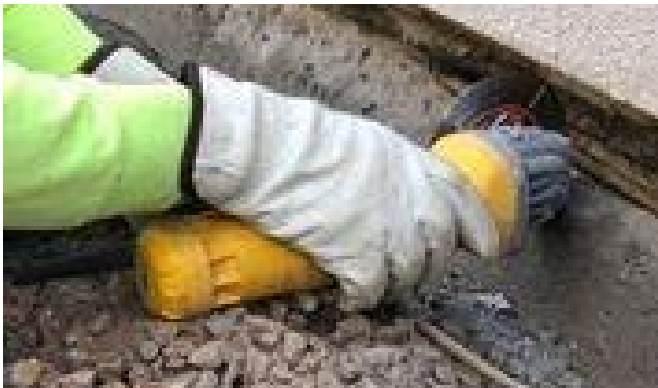
Step Two

Cut out all rusted rebar. Yes, ALL of it!

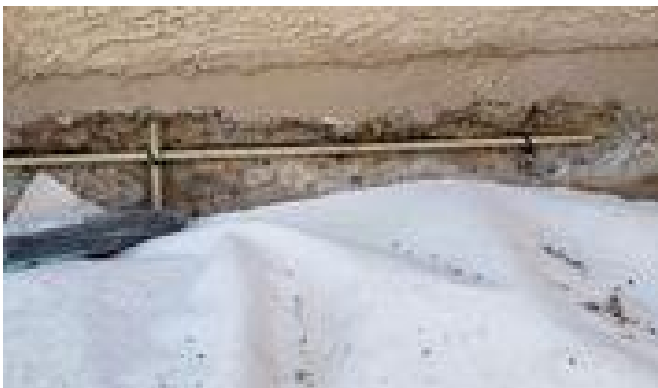
Step Three

Drill and dowel ends and middle sections every 5 feet.

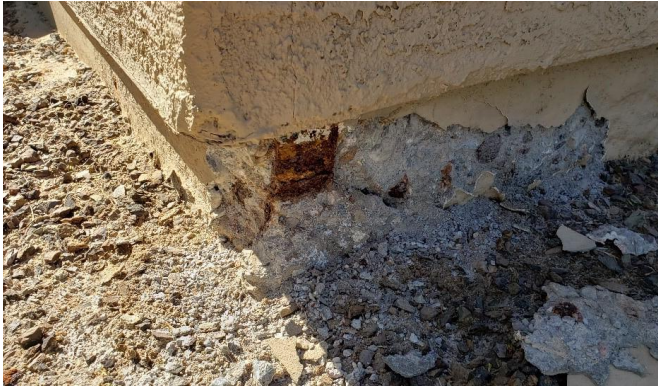
Step Four

If tie down straps are encountered, remove them completely

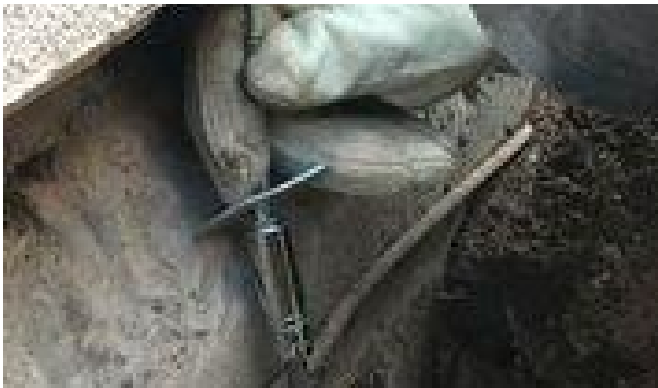
Step Five

Drill new 8" anchors into the base plate and up into the stud.

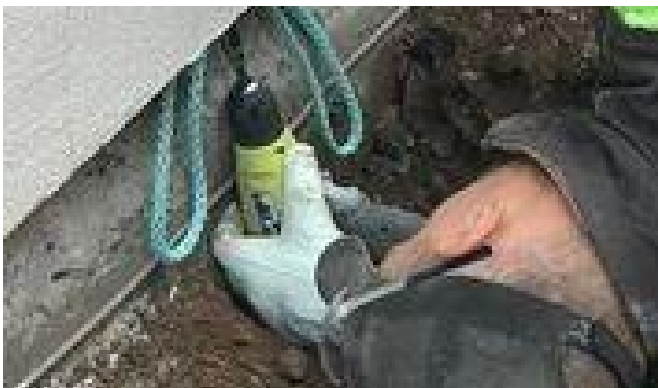
Step Six

Insert poly propylene loop in to anchor washer while drilling.

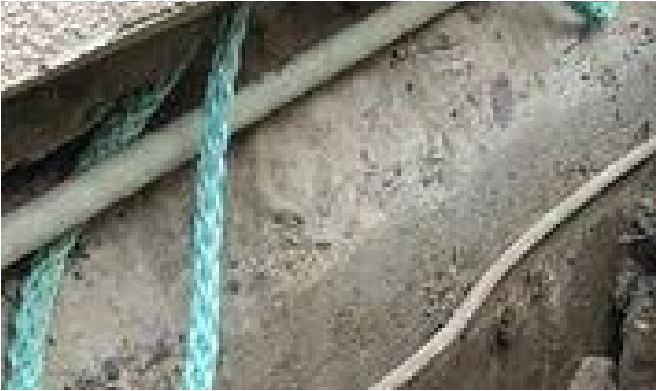
Step Seven

Insert horizontal composite bar into loops.

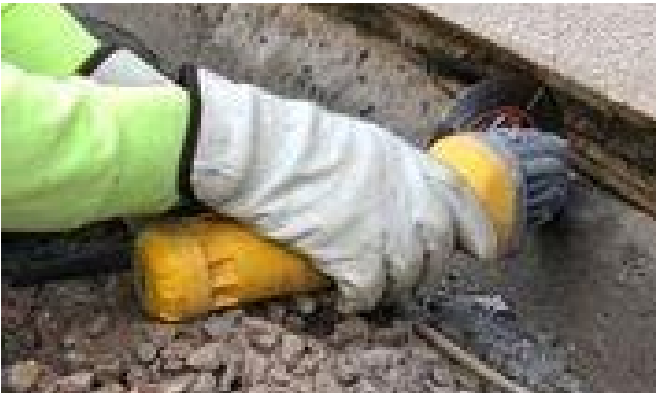
Step Nine

Patch back with high strength low shrink grout mix.

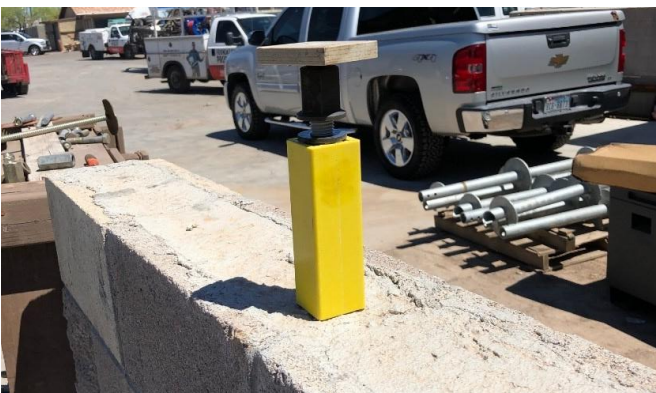
Step Ten

If the wall is completely deteriorated and loses all capacity to bear the load then insert composite shoring jacks as needed.
